# High Power Wall Connector Fuse Upgrade

<b>Classification</b>	Repair Bulletin	<b>Section/Group</b>	50 - External Charging Connectors	<b>Country/Region</b>	North America
<b>Year</b>	All	<b>Model</b>	Model S	<b>Version</b>	All

This Service Bulletin supersedes SB-13-50-004 R2, dated 3-Jan-14. Each content change is marked by a vertical line in the left margin. Discard the previous version and replace it with this one.

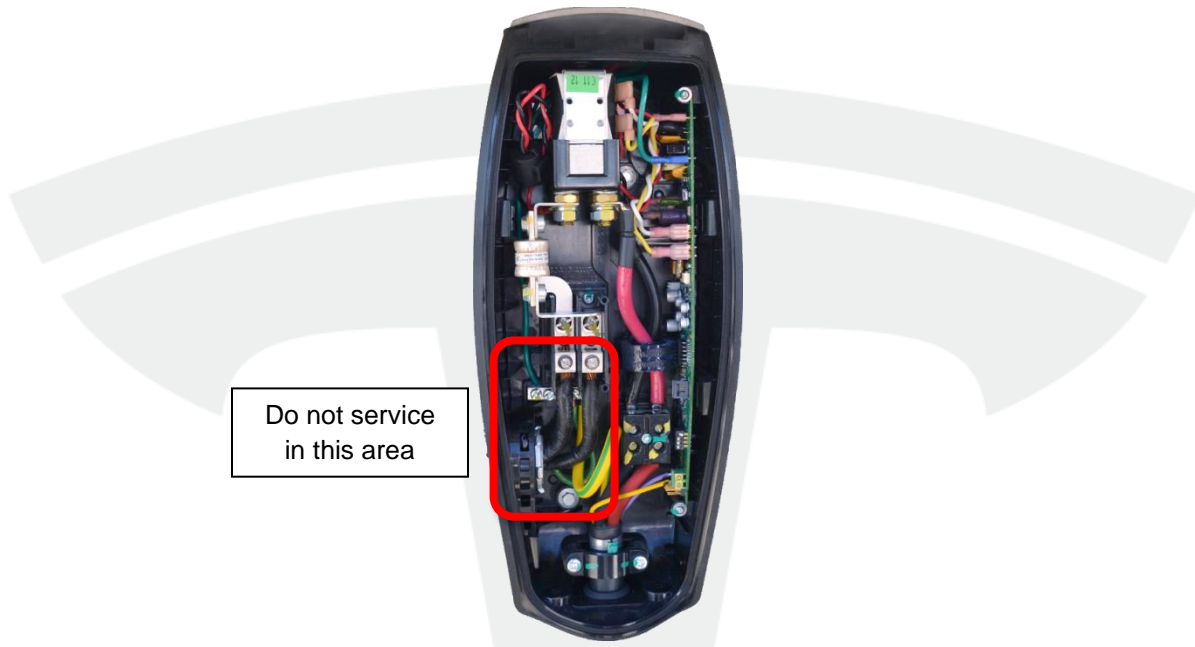
**Figure 3**

**⚠ CAUTION:** Do not service the area from the utility input to the left terminal blocks (Figure 3). This wiring is considered house wiring, and must be connected and serviced by a certified electrician.

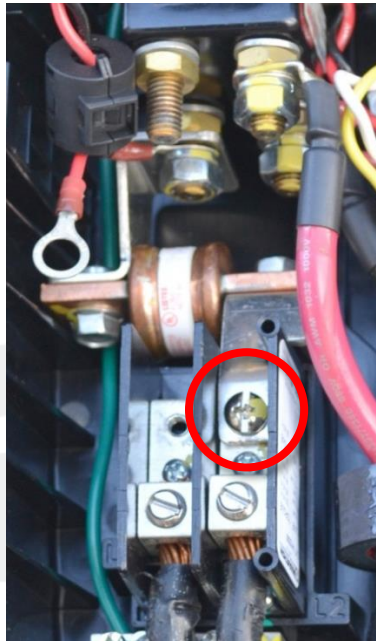
**Figure 9**

**NOTE:** The lower bus bar on the updated inner fuse connects to the right (L2) terminal. The original inner fuse was connected to the left (L1) terminal.

11. Position the new inner fuse. Install the screw at the L2 terminal (torque 3 Nm) (Figure 9).
