Replace Aeroshield Support Tab, HV Battery 2.0

Classification	Repair Bulletin	Section/Group	16 - Battery System	Country/Region	All
Year	All	Model	Model S, Model X	Version	HV Battery 2.0

This Service Bulletin supersedes SB-15-16-003, dated 6-Nov-15. Each content change is marked by a vertical line in the left margin. Discard the previous version and replace it with this one.

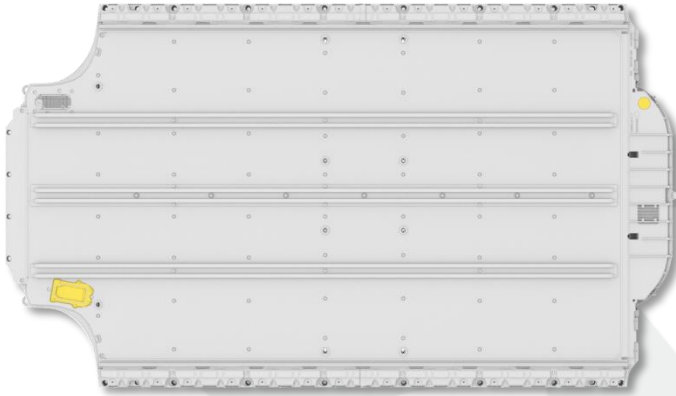
Figure 2 (Underside of HV Battery 2.0; fuse cover and discharge port highlighted)

NOTE: This procedure applies only to HV Battery 2.0 (Figure 2). Refer to SB-15-16-002 for HV Battery 1.0 and 1.5 (Figure 3).

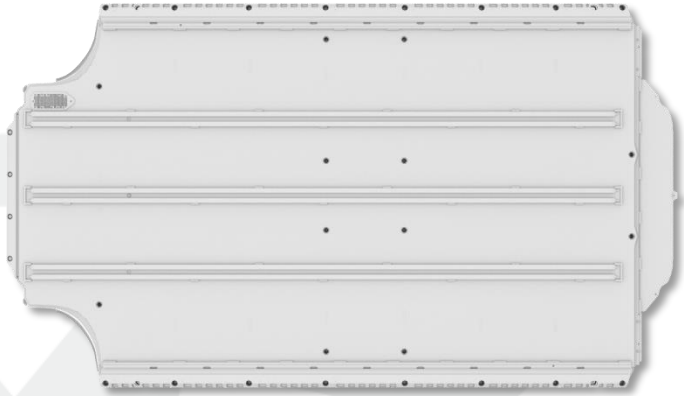
Figure 3 (Underside of HV Battery 1.0/1.5; no fuse cover or discharge port)
