Readjust Hood Latch

Classification	Campaign Bulletin	Section/Group	11 - Closures	Country/Region	United States, Canada
Year	2018	Model	Model 3	Version	All

On certain Model 3 vehicles, the hood latch might be out of alignment, causing a possible interference with the underhood storage unit.

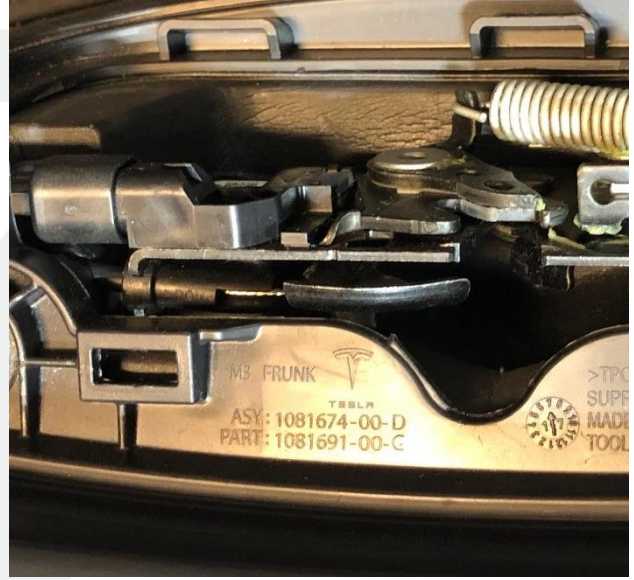
Figure 2

1. Remove the hood latch cover (refer to Service Manual procedure 15241102).
2. Inspect the underhood storage unit near the hood latch:
 - If the underhood storage unit is damaged from contacting the hood latch striker (Figure 1), continue to the next step.
 - If no damage is found on the underhood storage unit (Figure 2), skip to step 5.

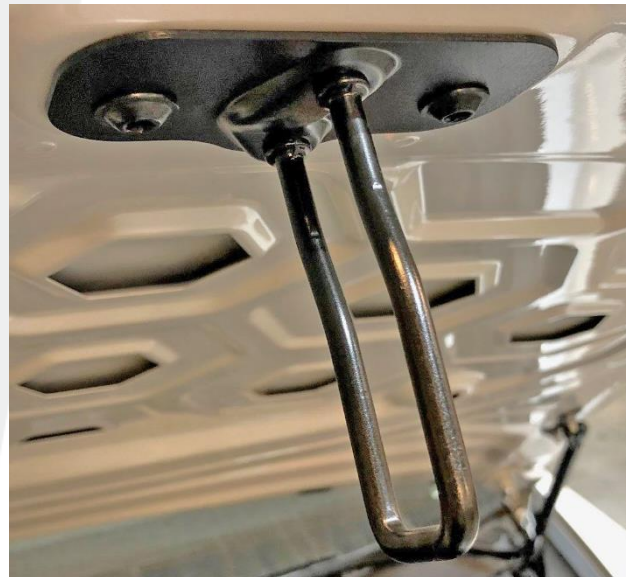
✔ Figure 7 (No scrape marks at the front of the hood latch striker)
