Reposition Forward Junction Box HV Cables

Classification	Campaign Bulletin	Section/Group	44 - High Voltage System	Country/Region	Europe, APAC
Year	2016	Model	Model S	Version	RHD RWD

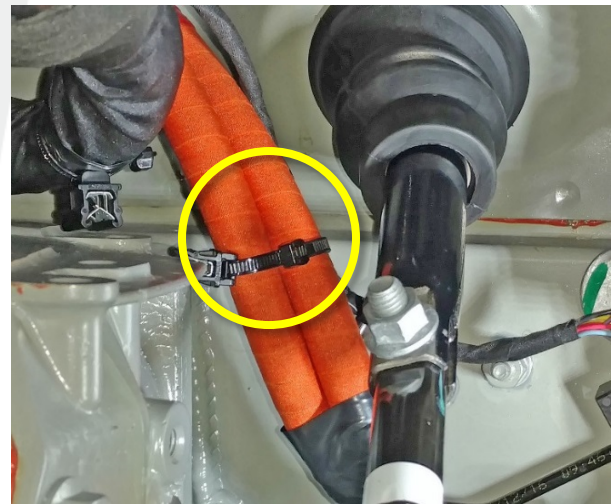
Figure 3

On some right hand drive rear wheel drive vehicles, the HV Cables on the RH side of the forward junction box might contact the steering shaft. Over time, repeated contact between the HV cables and the steering shaft might lead to an error message on the touchscreen and prevent the vehicle from starting.

4. Route the HV cables so that they bend away from the shaft (Figure 2), then secure them with the cable tie (Figure 2).
