Replace Huck BOM Fastener on Front Seats

Classification Repair Bulletin **Section/Group** 13 - Seats **Country/Region** All

Year 2015-2018 **Model** Model S, Model X **Version** All

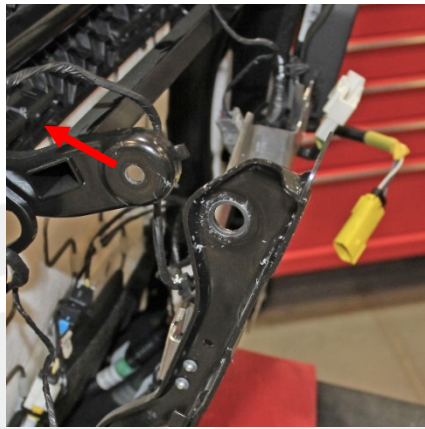
Figure 5

6. Remove and discard the Huck BOM body and head.
7. Remove any debris from the Huck BOM body and head from the work area.
8. Move the inner seat arm out of the working area (Figure 5).
