<b>Tesla, Inc.</b> <b>Service Bulletin</b>		<h2 style="margin: 0;">Inspect Front Lower Lateral Links</h2>	
<b>SB-21-31-003</b> December 2, 2021		<b>R3</b>	
<b>Classification</b> Recall Bulletin		<b>Section/Group</b> 31 - Suspension	<b>Mobile Service</b> Limited
<b>Model Year</b> 2019–2021	<b>Model</b> Model 3, Model Y	<b>Country/Region</b> All	<b>Version</b> All
<small>The model(s) and model year(s) listed are a general approximation of the affected VIN list. Refer to the VIN/Bulletin Tracker or Customer/Vehicle profile to determine applicability of this bulletin for a particular vehicle.</small>

### Condition

On certain Model 3 and Model Y vehicles, the bolts that secure the front lower lateral links to the subframe may not have been torqued to internal specification.

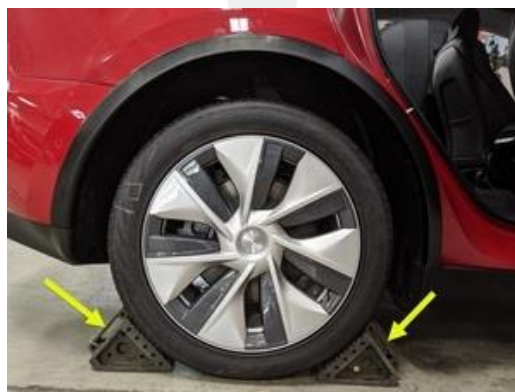
Figure 3

1. Chock the RH rear wheel (Figure 3).

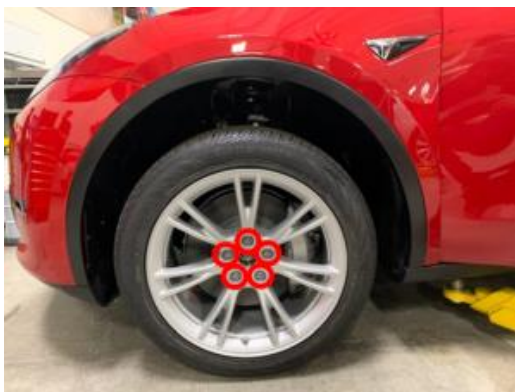
**Figure 4**

3. Loosen the LH front wheel (Figure 4).

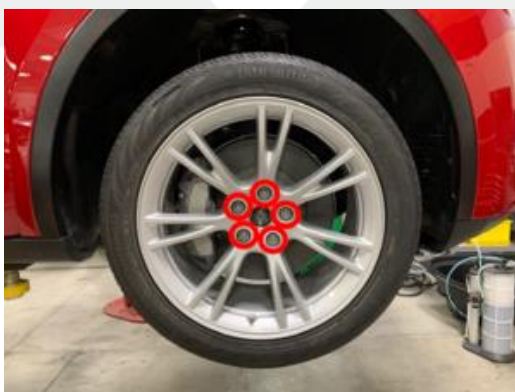
**Figure 5**

4. Raise and support the LH front of the vehicle (refer to Service Manual procedure 10000605; [Model 3](#), [Model Y](#)).
5. Remove the LH front wheel lug nuts (Figure 5), and then remove the LH front wheel from the vehicle.

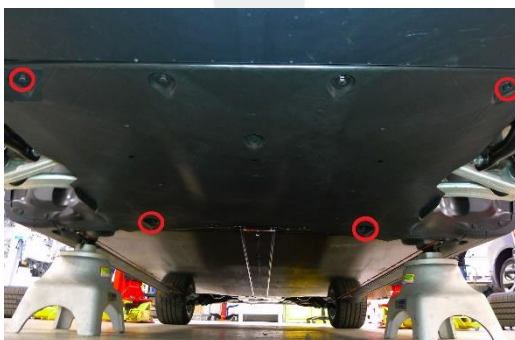
**Figure 6**

6. Repeat step 1 through step 5 to lift the RH front of the vehicle.
7. Remove the bolts (x4) that attach the corners of the front aero shield panel to the vehicle (Figure 6).
