TN-21-16-001 December 15, 2021

Tesla, Inc. Technical Note
Model:	Vehicle System:	Region:
Model S Palladium Model X Palladium	16 - Battery System	All

Inspect the Model S Palladium and Model X Palladium HV Battery for Underside Damage

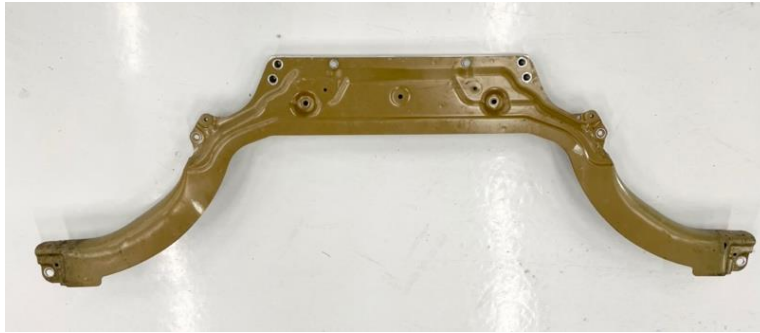
Figure 8 – Front Skidplate

3. Inspect the HV cables and passthroughs.
4. If there is damage to the leading edge above the front skidplate, see also “Leading Edge” section.
5. If there is damage to that extends onto the pyro cover, see also “Pyrotechnic Fuse Cover” section.

6. If there is damage that extends onto the front ancillary, see also “Front Ancillary” section.
7. Remove and assess damage to components: HV cables, passthroughs, fasteners, baseplate, etc.

Suggest repair to customer:

- Deburr the area with a hand deburring tool to remove the sharp edges if sharp edges are found.
- Recommend the replacement of the front skidplate if the frontskid plate, or part of the skidplate, is detached.
- Recommend the replacement of the HV cables if the HV cables are damaged above the front skidplate.
- Recommend the replacement of the passthrough if a passthrough is damaged above the front skidplate.
- Recommend the replacement of the fastener if a fastener attaching the front skidplate to the vehicle is damaged or stripped.
- Re-tap the fastener hole if a fastener hole is damaged and the fastener cannot withstand full torque.
- Recommend HV battery replacement if:
 - The HV battery enclosure fails the leak test due to impact.
 - The HV battery enclosure has low isolation due to impact.

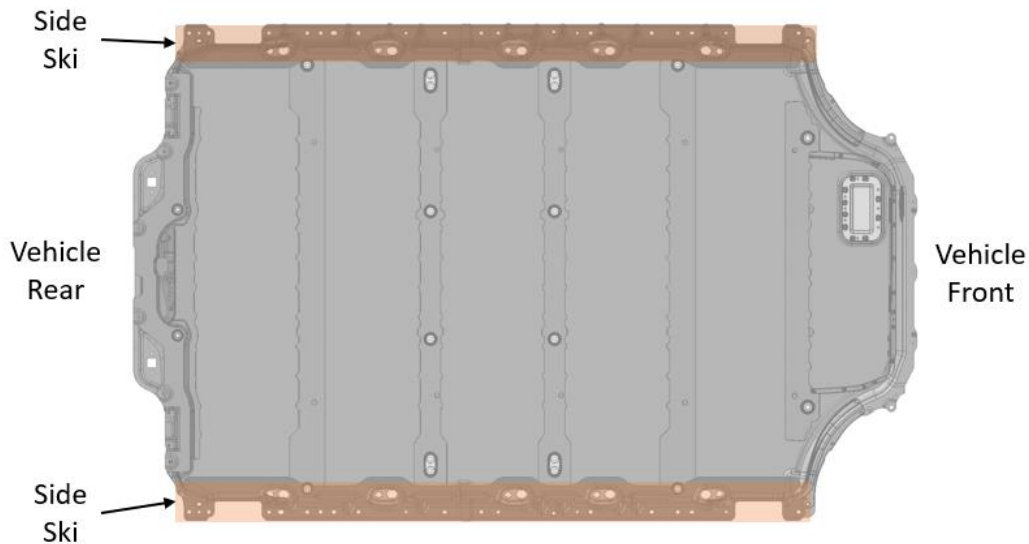
Figure 11 – Side Skis

There are two side skis (Figure 11). For each side ski, there is a “side ski zone,” which extends 5 inches (127 mm) inward from the edge of the HV battery.

Suggest repair to customer:

- Recommend HV battery replacement if:
 - The side ski, or part of the ski, is detached from the HV battery.
 - The HV battery enclosure fails the leak test due to impact.
 - The HV battery enclosure has low isolation due to impact.
- Recommend the replacement of the jack pad if a jack pad has extensive damage where it cannot be used to safely lift the vehicle.
- Re-tap fastener hole if a fastener hole is damaged and the fastener cannot withstand full torque.
- Deburr the area with a hand deburring tool to remove the sharp edges if sharp edges are found (Figure 12).

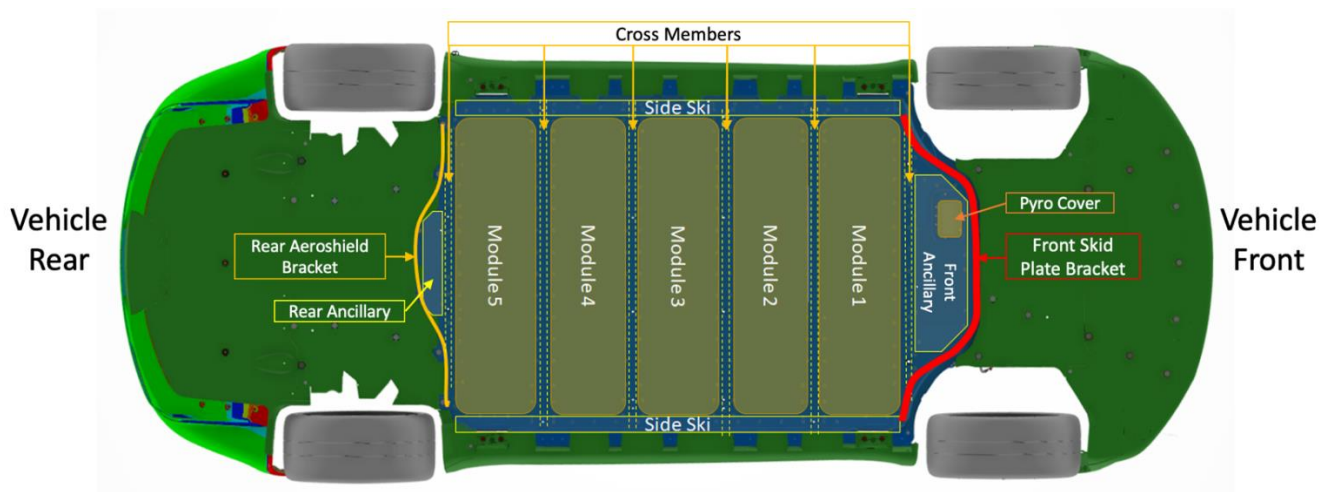
Figure 13 – Baseplate Zones

Baseplate module zones are located between the crossmember zones. When a baseplate module zone is damaged, follow these steps:

Baseplate cross member zones separate the baseplate module zones. When a baseplate cross member zone is damaged, follow these steps:

- Deburr the area with a hand deburring tool to remove the sharp edges if sharp edges are found (Figure 14).
- Recommend HV battery replacement if:
 - A dent is **7 mm** or more in depth (Figure 15).
 - The HV battery enclosure fails the leak test due to impact.
 - The HV battery enclosure has low isolation due to impact.

- Deburr the area with a hand deburring tool to remove the sharp edges if sharp edges are found (Figure 14).
- Recommend HV battery replacement if:
 - A dent is **3 mm** or more in depth (Figure 15).
 - The HV battery enclosure fails the leak test due to impact.
 - The HV battery enclosure has low isolation due to impact.

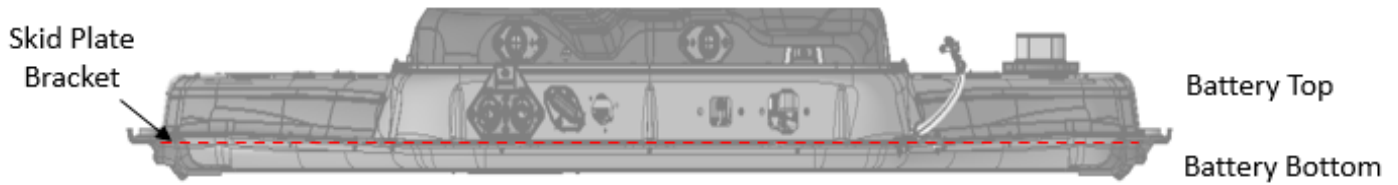
Figure 16 – Leading Edge

The leading edge of the HV battery is above the front skidplate bracket, shown as a dashed red line (Figure 16). Anything below the front skidplate bracket is part of the front ancillary or the pyro cover. When the leading edge area is damaged, follow these steps:

Suggest repair to customer:

- Deburr the area with a hand deburring tool to remove the sharp edges if sharp edges are found.
- Recommend the replacement of the HV cables if the HV cables are damaged above the front skidplate.
- Recommend the replacement of the passthrough if a passthrough is damaged above the front skidplate.
- Recommend HV battery replacement if:
 - The HV battery enclosure fails the leak test due to impact.
 - The HV battery enclosure has low isolation due to impact.

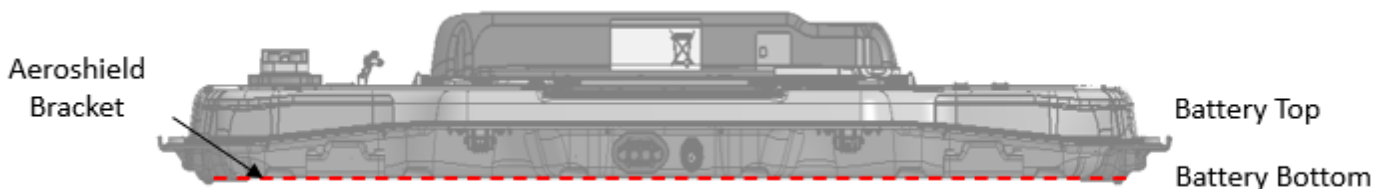
Figure 17 – Rear Edge

The rear edge of the HV battery enclosure is above the aero shield bracket, shown as a dashed red line (Figure 17). When the rear edge area is damaged, follow these steps:

Suggest repair to customer:

- Deburr the area with a hand deburring tool to remove the sharp edges if sharp edges are found.
- Recommend the replacement of the HV cables if the HV cables are damaged above the aero shield bracket.
- Recommend HV battery replacement if:
 - A passthrough is damaged above the aero shield bracket.
 - The HV battery enclosure fails the leak test due to impact.
 - The HV battery enclosure has low isolation due to impact.

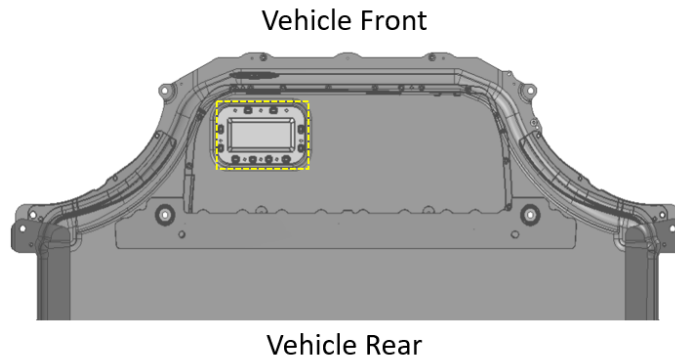
Figure 18 – Pyro Cover

The pyrotechnic fuse cover is boxed below in the yellow dashed line (Figure 18). When the pyrotechnic fuse cover area is damaged, follow these steps:

**NOTE:** If damages on a pyrotechnic fuse cover section extend onto the front ancillary, follow these steps.

Suggest repair to customer:

- Recommend the replacement of the pyrotechnic fuse cover if the pyrotechnic fuse cover is missing, detached, damaged, or something is lodged between the cover and front ancillary.
- Deburr the area with a hand deburring tool to remove the sharp edges if sharp edges are found.

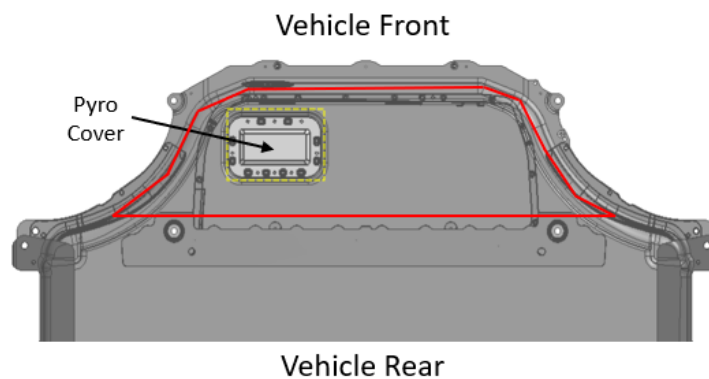
Figure 19 – Front Ancillary

The front ancillary is marked in red below (Figure 19). The pyrotechnic fuse cover area, yellow dashed box, is **NOT** part of this area. If damages on the front ancillary area extend onto the pyrotechnic fuse cover area, see also the “Pyrotechnic Fuse Cover” section above. When the front ancillary area is damaged, follow these steps:

Suggest repair to customer:

- Deburr the area with a hand deburring tool to remove the sharp edges If sharp edges are found.
- Recommend HV battery replacement if:
 - The HV battery enclosure fails the leak test due to impact.
 - The HV battery enclosure has low isolation due to impact.

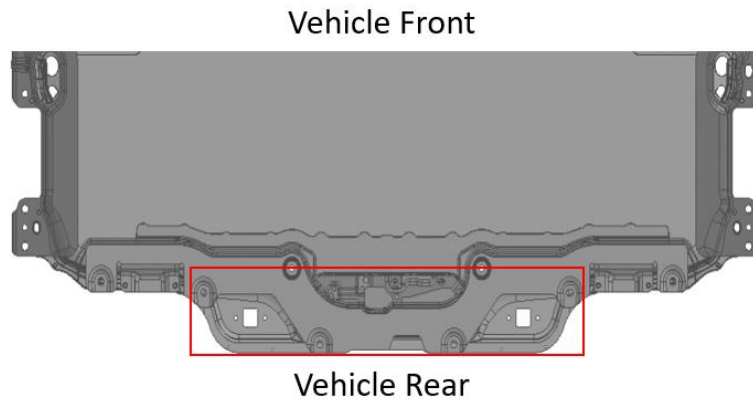
Figure 20 – Rear Ancillary

The rear ancillary area is identified with a red box in Figure 20. When the rear ancillary area is damaged, follow the steps below:

Suggest repair to customer:

- Deburr the area with a hand deburring tool to remove the sharp edges If sharp edges are found.
- Recommend HV battery replacement if:
 - The HV battery enclosure fails the leak test due to impact.
 - The HV battery enclosure has low isolation due to impact.
