# Replace Charge Port

<b>Classification</b>	Repair Bulletin	<b>Section/Group</b>	44 - High Voltage System	<b>Country/Region</b>	North America and APAC
<b>Year</b>	2017	<b>Model</b>	Model S, Model X	<b>Version</b>	All

On some Model S and Model X vehicles with charge port part number 1026041-00-M or 1026041-00-N, the charge port insertion guide might prevent the charge port latch from fully engaging. If the charge port latch is not fully engaged, the charge port light is amber or orange, and maximum AC charge current is not allowed. Using a Supercharger is not allowed if the charge port latch is not fully engaged.

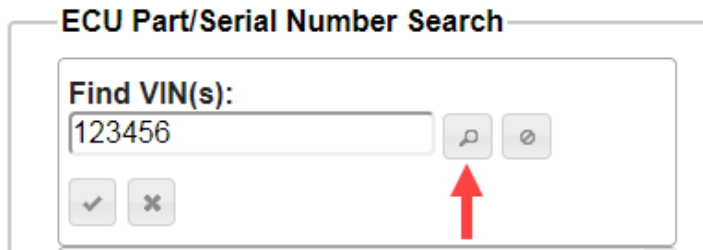
- b. In the top menu bar, click **P/S Numbers**.
- c. In the **Find VIN(s)** field, enter the last 6 digits of the VIN.
- d. Click the search button (the magnifying glass) to the right of the **Find VIN(s)** field.

**ECU Part/Serial Number Search**

Find VIN(s):  
123456

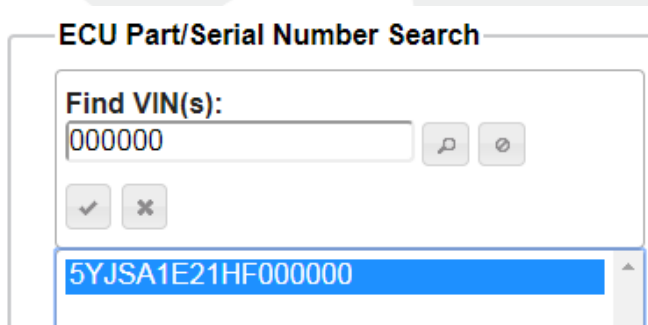
- e. Select the VIN from the results list.

**ECU Part/Serial Number Search**

5YJSA1E21HF000000

- f. Click **Search**.
- g. In the **Results** area, the **CP-mod** column indicates the part number and serial number of the charge port in the vehicle.
