DEFINITY[®]

Enterprise Communications Server

Release 7

Maintenance for R7si

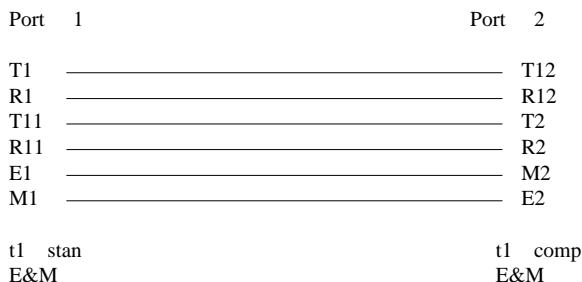
10. Locate the Tie Trunk port terminal connections at the cross-connect field. See [Table 5-5](#).
11. At the cross-connect field, disconnect outside trunk facilities from the Tie Trunk ports and mark the disconnected wires for later reconnecting the Tie Trunk ports back to normal operation. The D Impact Tool (AT-8762) is required to perform this step.
12. Use jumper wires (DT 24M-Y/BL/R/G and DT 24P-W/BRN) and the D Impact Tool to connect wiring between the two ports assigned in Step 9 at the cross-connect field. For example, if the two ports on the Analog Tie Trunk circuit pack are port 1 and 2, connect the wirings as shown below:

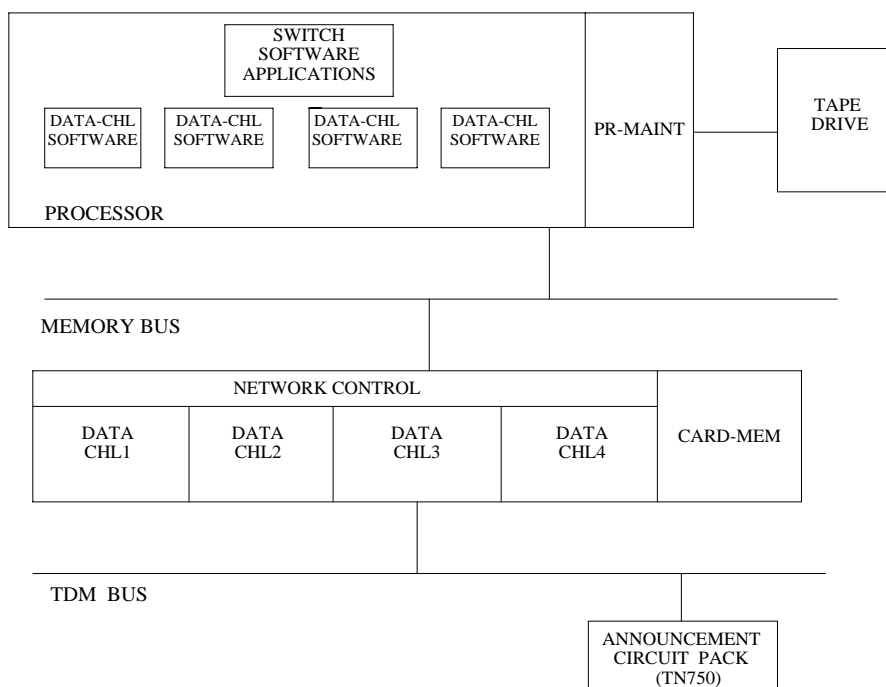
Figure 10-4. Connection of Announcement Circuit Pack to the System

Figure 10-4 shows the connection of the Announcement Circuit Pack to the system. To save or restore announcements, an ANNOUNCEMENT Data Extension must be administered, and at least one DATA-CHL (Network Control Data Channel) must be in the in-service/idle state.

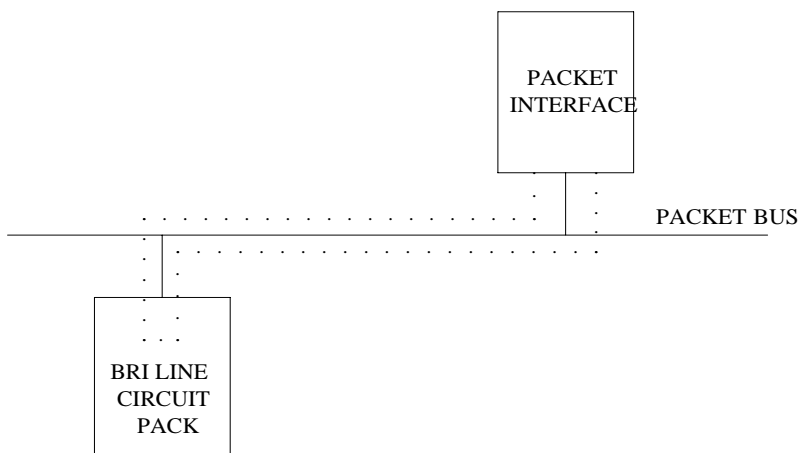
Figure 10-5. BRI Port Local LAN Looparound Path

This test verifies the connectivity of a BRI port across the LAN Bus and executes only if the port is out-of-service. The test aborts if calls associated with the port are in-progress. Failures of this test indicate either on-board faults associated with the ASAI-PT hardware on the circuit pack or problems with the LAN Bus, which is used to form connectivity between the switch and the ASAI-PT.

The dotted lines in Figure 10-5 show how a Looparound Test is performed across the Packet Bus for the D-channel.

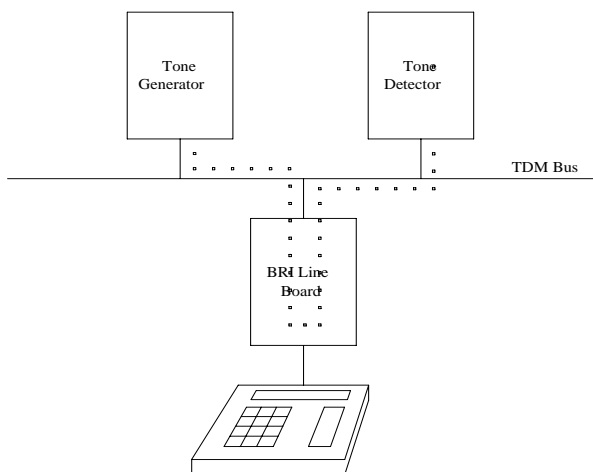
Figure 10-18. Path of the BRI Port Local TDM Loop Around

The dotted lines in Figure 10-8 show how a Loop Around Test is performed for the B-channels. The figure shows a terminal connected to a BRI line board using a TN556. If a TN2198 is used, the terminal would be connected to a NT1, and the NT1 to the BRI board.

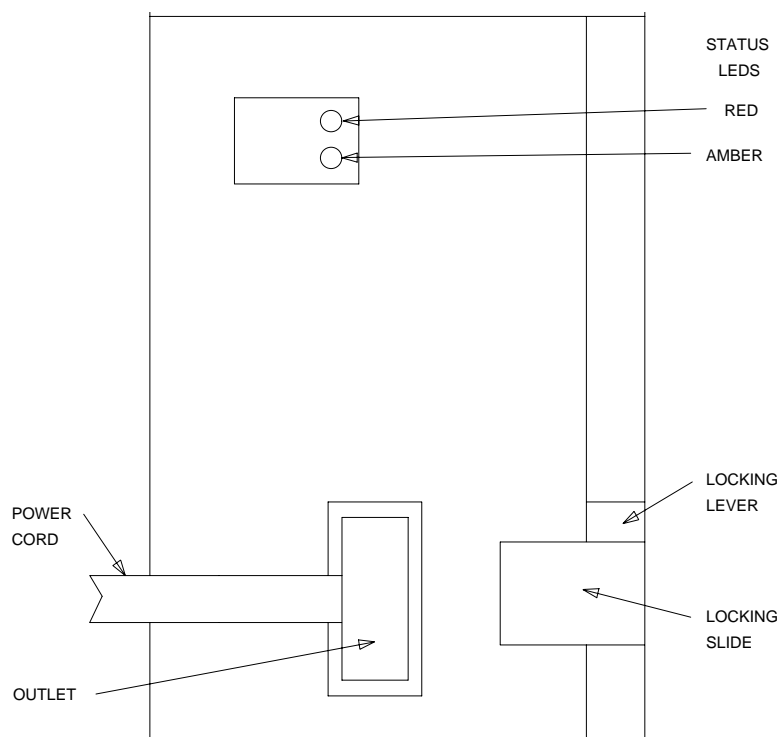
Figure 10-25. 631WA or 631WB AC Power Unit

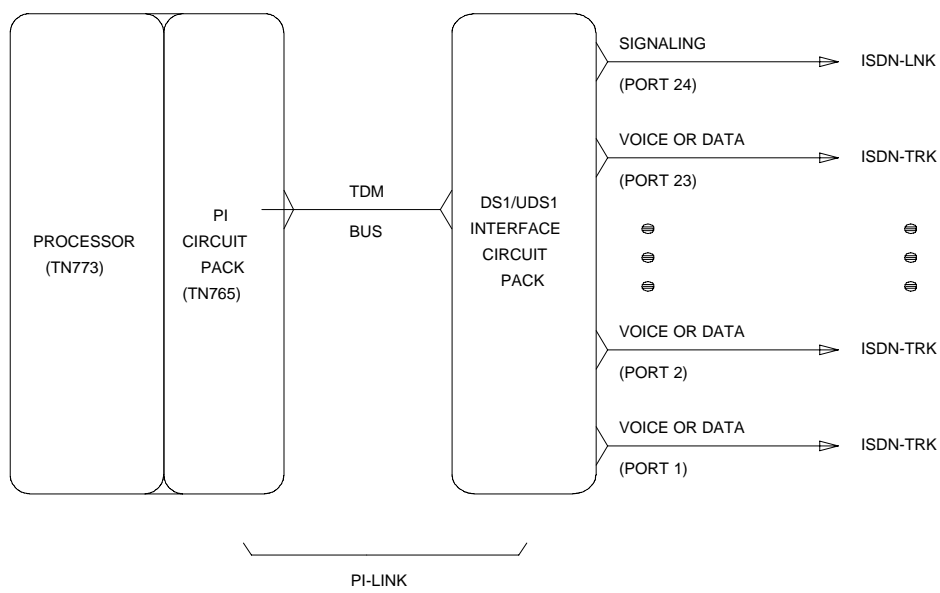
Figure 10-67. DS1 ISDN Trunk Interactions (24-channel interface)

As a port on a DS1 circuit pack (DS1-BD or UDS1-BD), and as part of a signaling group dependent on a D-channel (ISDN-LNK/ISDN-PLK) for signaling, operation of the ISDN-TRK is dependent on the health of these other maintenance objects. The ISDN D-channel in turn depends on the Packet Bus (PKT-BUS)/Processor Interface Link (PI-LINK) (dependent on setup) for transmission through the system. Keep this hierarchy of dependencies in mind when diagnosing problems.
