Replace Sunvisors Due to Misprinted Labels, Canada

Classification	Campaign Bulletin	Section/Group	15 - Interior Trim	Country/Region	Canada
Year	2016	Model	Model X	Version	All

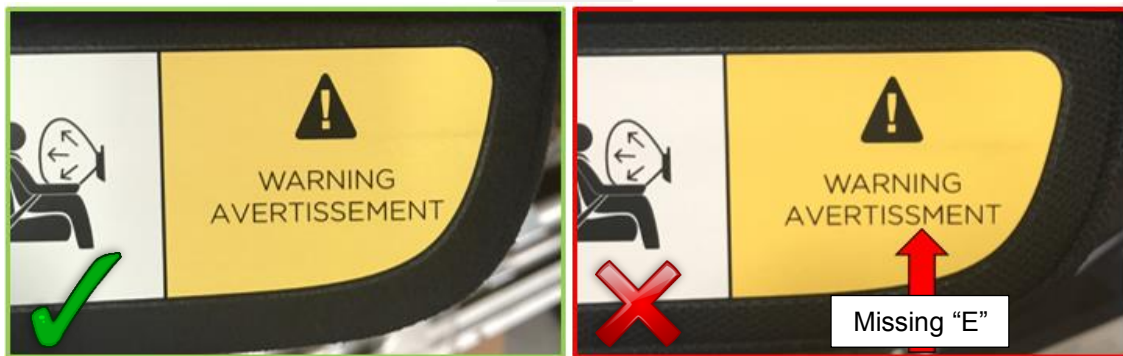
Figure 1

Some Canada-market Model X vehicles have sunvisors with misprinted labels.

- Inspect the LH and RH sunvisors (Figure 1).
 - If either visor label has “Warning Avertissement” (with a missing "E") printed on it, replace the affected visor(s) (refer to Service Manual procedure 15051002).

Check the labels on the sunvisors. Replace the sunvisor(s), if necessary.

NOTE: Revision -G visors are slightly different in appearance than earlier versions. If installing a revision -G visor, replace both the LH and RH visors.
 - If both visor labels have “Warning Avertissement” printed on them, no further work is required.
