# Replace Continental 19" Tires Date Coded 1317

<b>Classification</b>	Campaign Bulletin	<b>Section/Group</b>	34 - Wheels & Tires	<b>Country/Region</b>	United States
<b>Year</b>	2017	<b>Model</b>	Model 3	<b>Version</b>	All

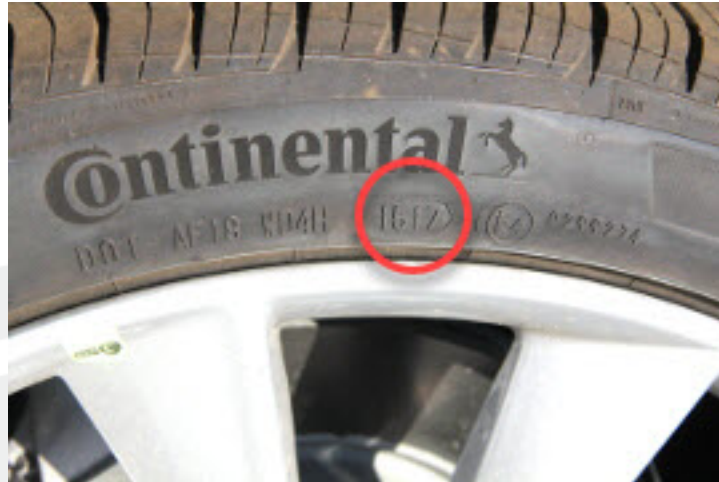
1. Inspect the date code of the front LH tire (Figure 1).

**Figure 1 (date code circled in red)**

- If the date code on the tire is 1317, go to step 2.
  - If the date code on the tire is not 1317, go to step 6.
2. Remove the tire and wheel from the vehicle (refer to Service Manual procedure 34015001).
  3. Dismount the tire from the wheel, and mount the replacement tire onto the wheel (refer to Service Manual procedure 34021002).  
**NOTE:** Make sure the date code of the replacement tire is not 1317.
  4. Balance the tire and wheel (refer to Service Manual procedure 34022005).
  5. Install the tire and wheel onto the vehicle (refer to Service Manual procedure 34015001).
  6. Repeat step 1 through step 5 for the front RH tire, rear RH tire, and rear LH tire.
