**Tesla, Inc.**  
Service Bulletin

## Replace LH Repeater Camera

**SB-21-17-006**

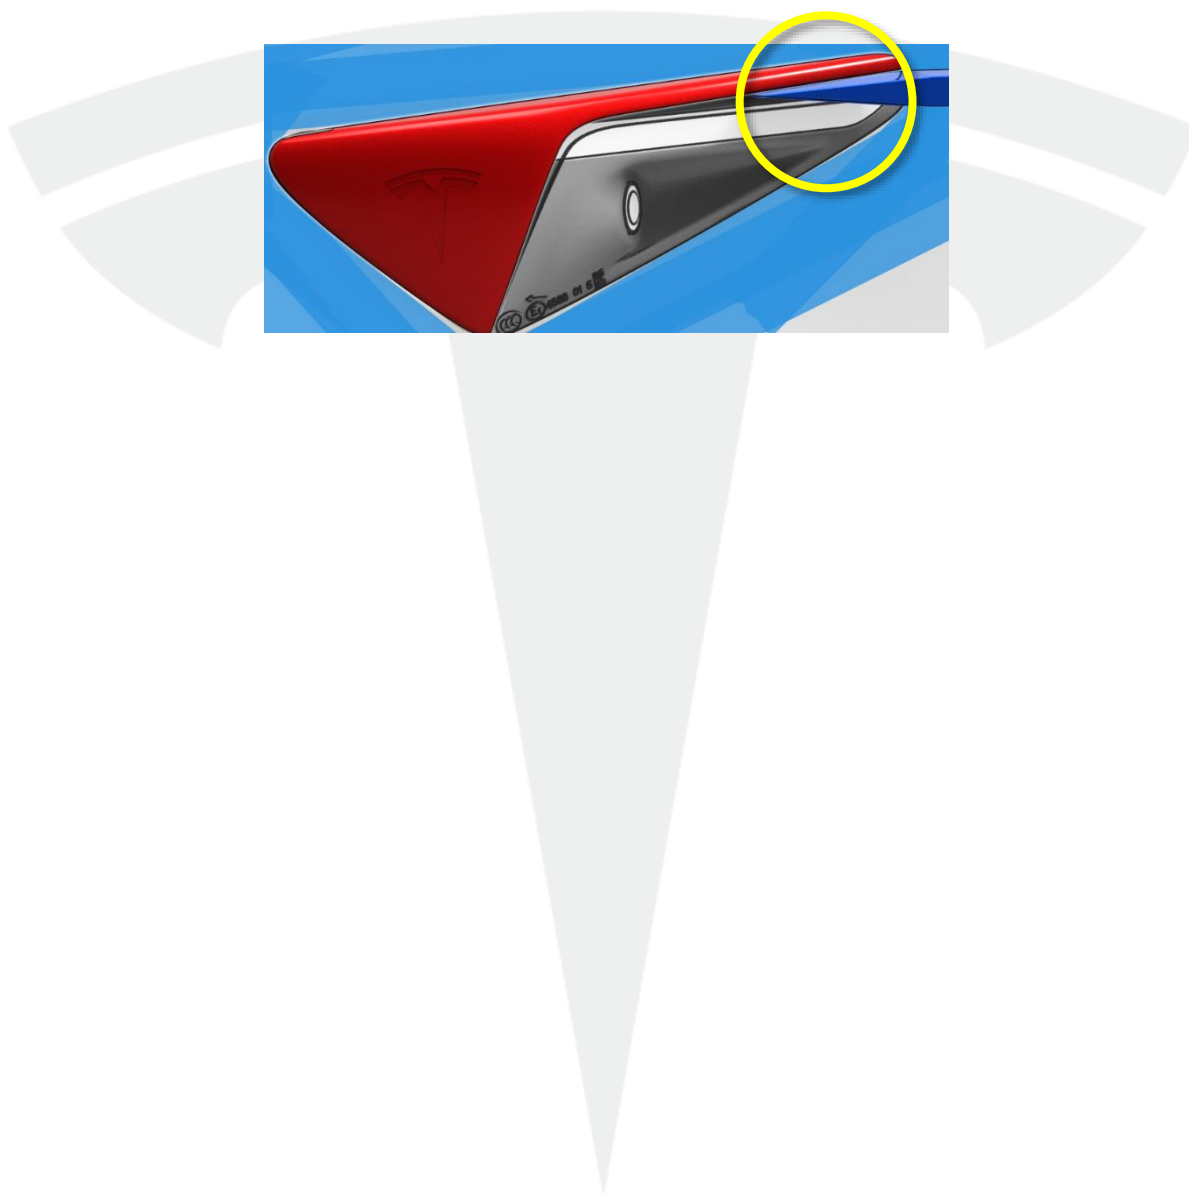
1. Carefully insert a trim tool under the rear edge of the trim, and then separate it from the camera (Figure 1).
2. Align the top of the new trim onto the camera, and then apply equal pressure to fully attach the trim onto the camera.

**NOTE - Model 3 Only:** The new side repeater camera aero rib trim comes in carbon black. If the vehicle currently has a chrome aero rib trim, replace the carbon black trim on the new camera with chrome:
